Lake Rukwa Basin Water Board

Water Status Second Quarter 2023/2024

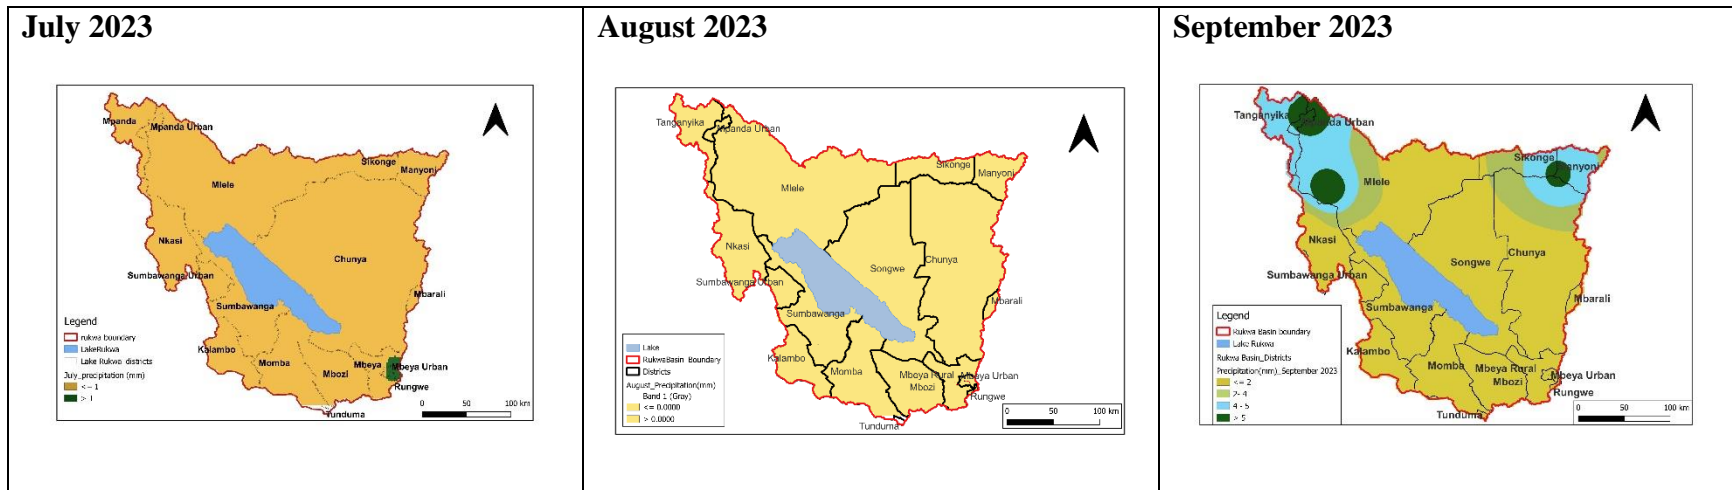
The monthly distribution of rainfall over the basin is characterized by unimodal rainfall patterns (End of January to Mid of May). Overall, monthly rainfall estimates within the year indicate wide spatial and temporal rainfall variability in the basin. Minimum rainfall is normally seen in the Northeast part of the basin and the maximum rainfall estimates are normally observed in the North and South part of the basin. In September 2023, the Rukwa Basin received rainfall in the North and East parts especially in the Katuma and Rungwa Catchment. In July 2023, Songwe catchments received more rainfall than other catchments. In August 2023, no rainfall was received in all catchments districts in the Basin. A full analysis of how much rainfall was detected in each catchment is given in this report. The map below indicates how rainfall was distributed over the reporting period for each month.

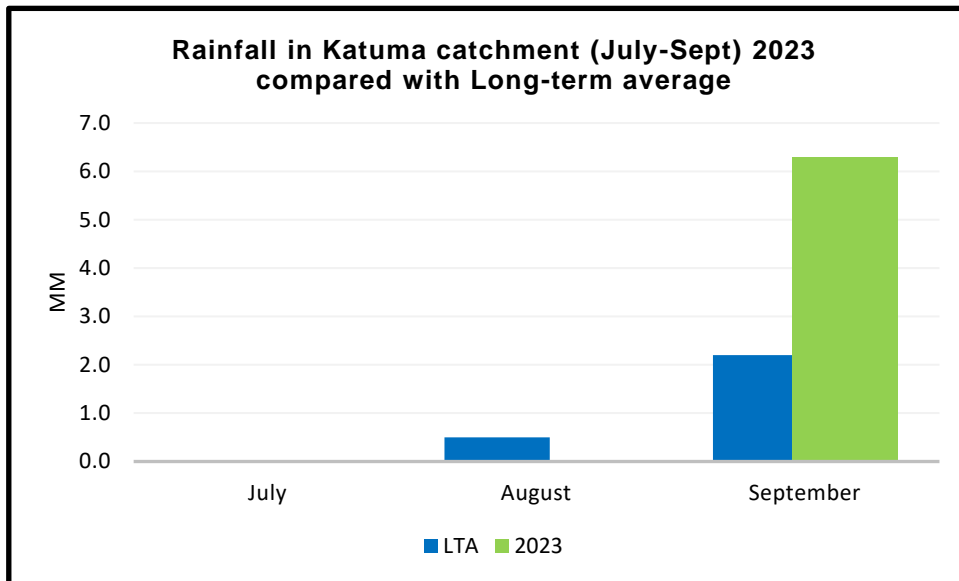
Rainfall over Katuma catchment

Katuma catchment normally experiences a unimodal rainfall pattern that is registered at mid of September. In July and August, there was a decrease in rainfall by 100%. In September, the rainfall recorded was above the average by 186.3% as compared to the long-term average of 1985-2021.

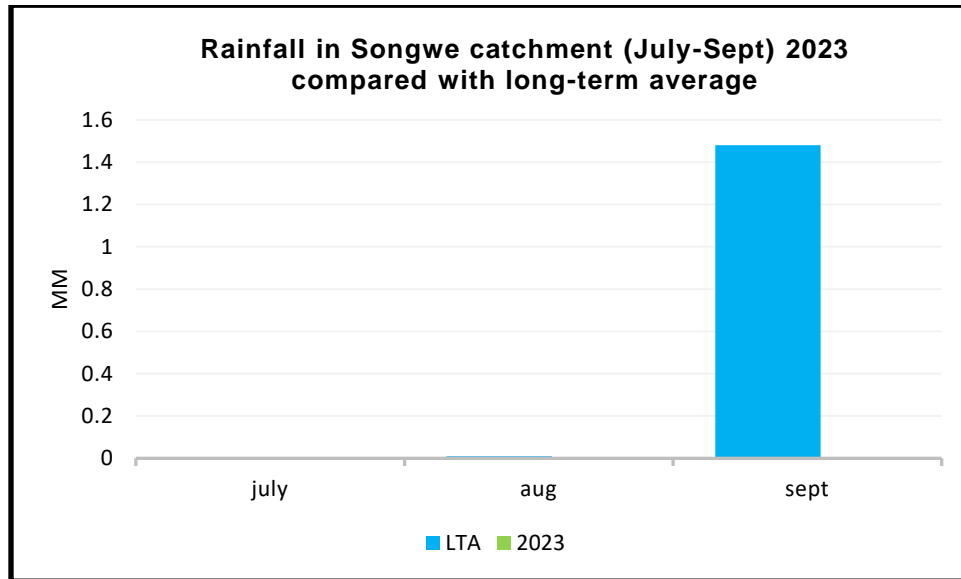
Rainfall over Songwe Catchment

In July, August and September, there was a decrease in rainfall by 100% compared to the long-term average of 1985-2021.

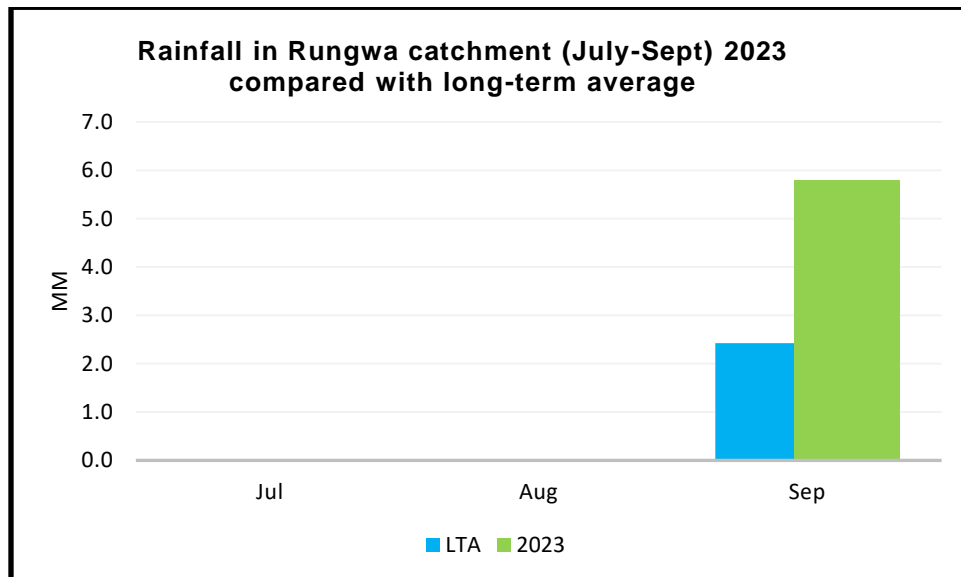
Rainfall over Rungwa Catchment

The Rungwa catchment experiences a normal climate in the Basin with little rainfall amounts recorded mainly in September compared to other catchments. In September the rainfall recorded was above the long-term average by an increase of 141.6%. In July and August, there was a decrease in rainfall by 100% compared to the long-term average of 1985-2021.

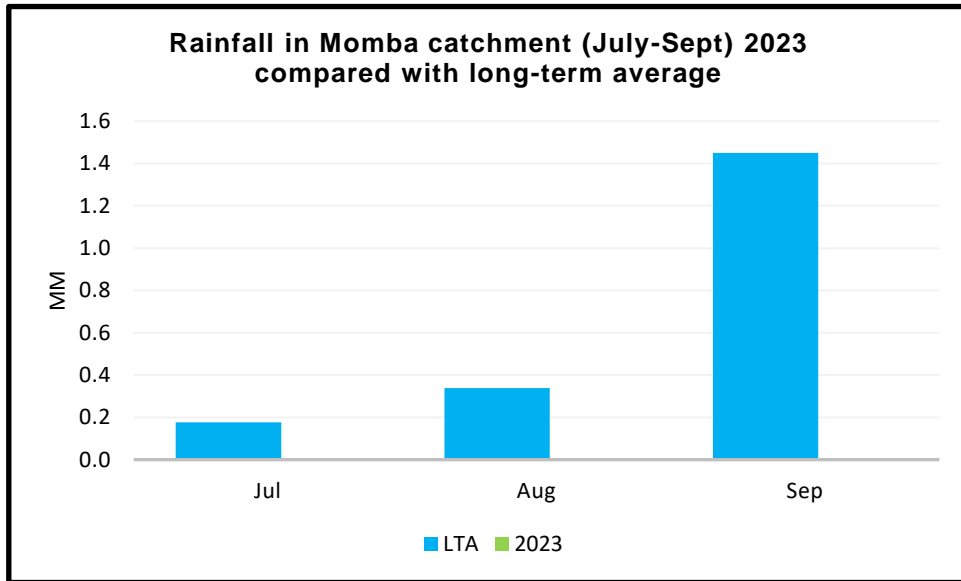
Rainfall over Momba Catchment

The Momba catchment no rainfall experienced in all reported periods. In the reported periods, there was a decrease in rainfall by 100% compared to the long-term average of 1985-2021.

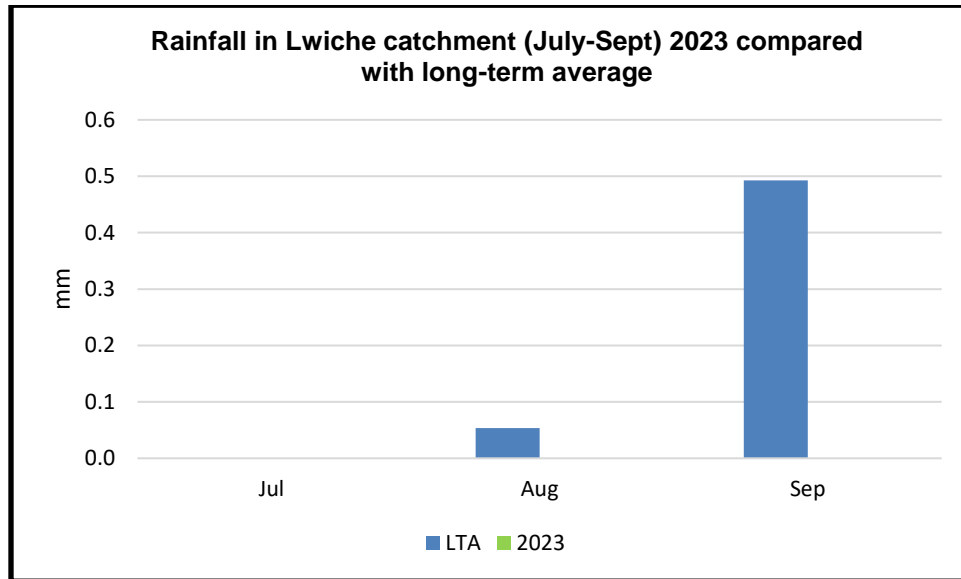
Rainfall over Lwiche Catchment

The Lwiche catchment no rainfall experienced in all reported periods. In July, August and September, there was a decrease in rainfall by 100% compared to the long-term average of 1985-2021.

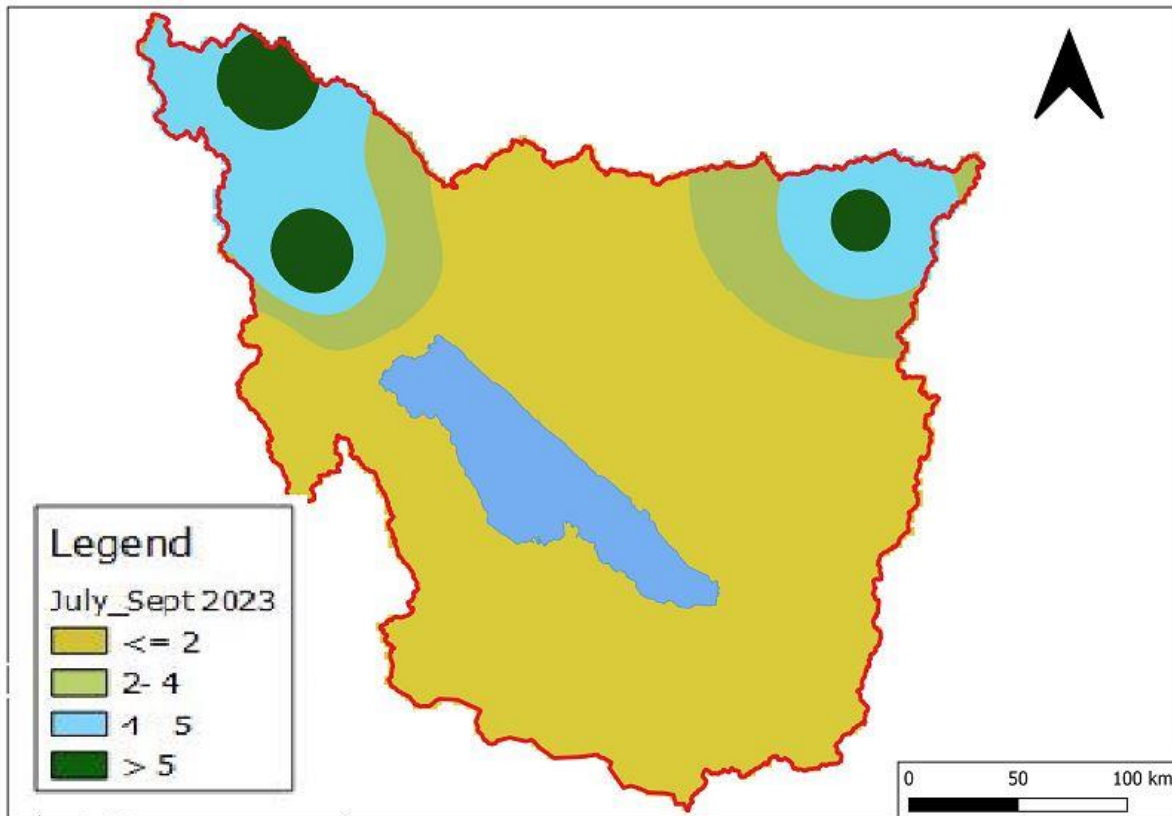
The Rukwa Basin normally experiences unimodal rainfall patterns. This analysis indicates that catchments in the Northern part experienced little rainfall during the reporting period. However, there was a slight increase in some catchments and a decrease in others as compared to the long-term average as shown in the previous section.

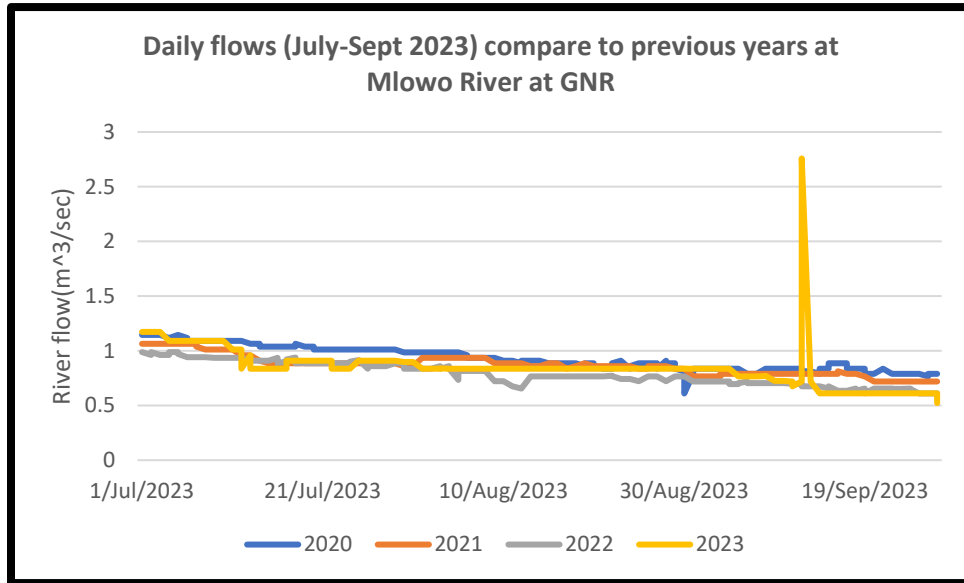
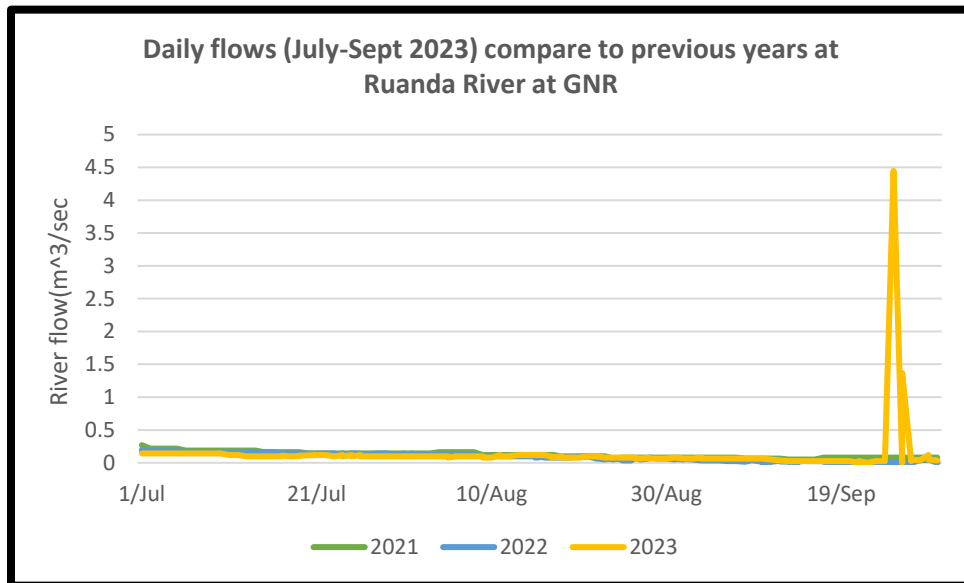
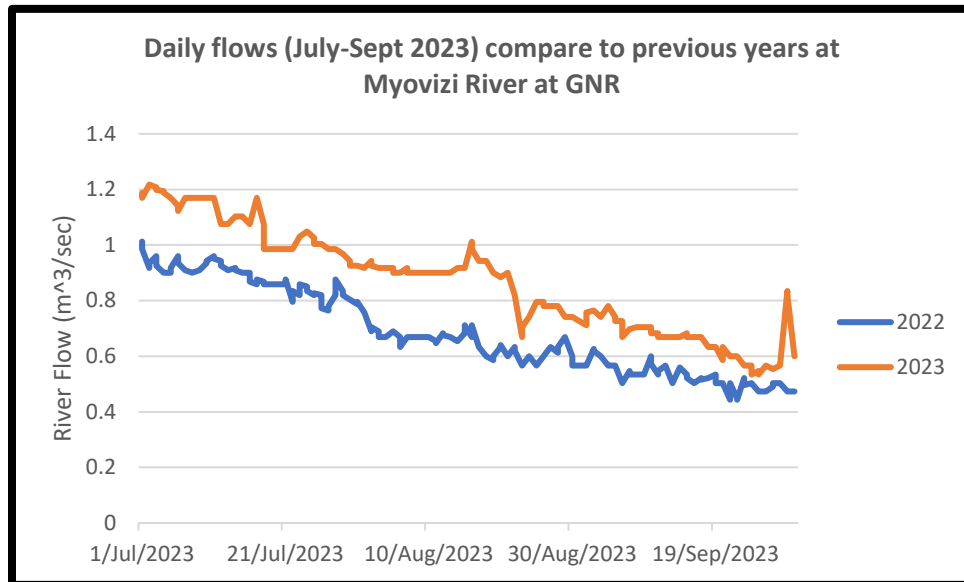
During the reporting period, a large part of the entire basin no rainfall experienced especially in July and August as explained above. Therefore, in September, the river flows in a large part of the

basin were reported to be higher than the previous years and in July and August the river flows were reported to be normal compared to the previous years as indicated in the figures below.

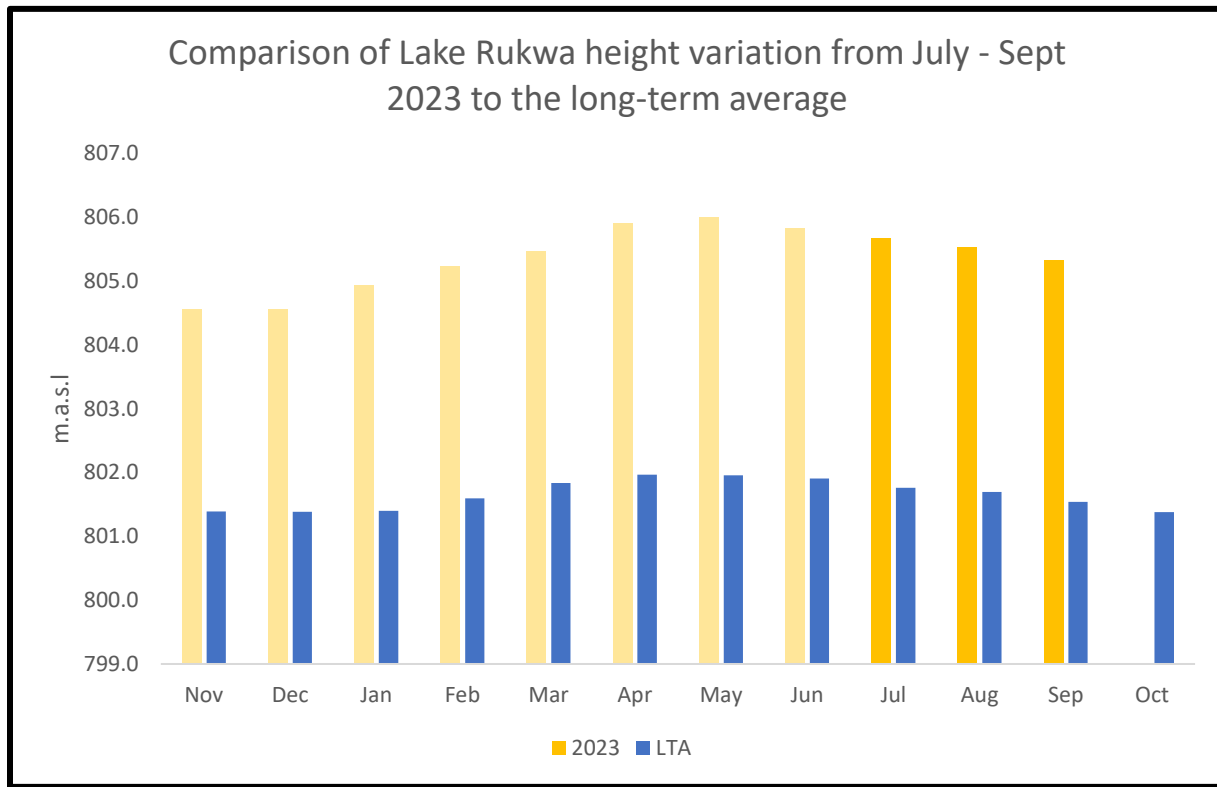
The rivers within the Rukwa basin are sensitive to changes in rainfall with variations impacting Lake Rukwa levels and river discharges. From July to September, the lake levels are seen to fluctuate with a high fall in all reported periods. The lake height is seen to be higher by about 4.0 meters as compared to the long-term average of 2014-2020.
